**BRUNSWICK HEADS TO YELGUN
PACIFIC HIGHWAY UPGRADE PROJECT
SECOND SIX MONTHLY REPORT ON
ENVIRONMENTAL PERFORMANCE**

JANUARY 2006 TO JULY 2006

Second Six Monthly Report

Volume 1 Main Report

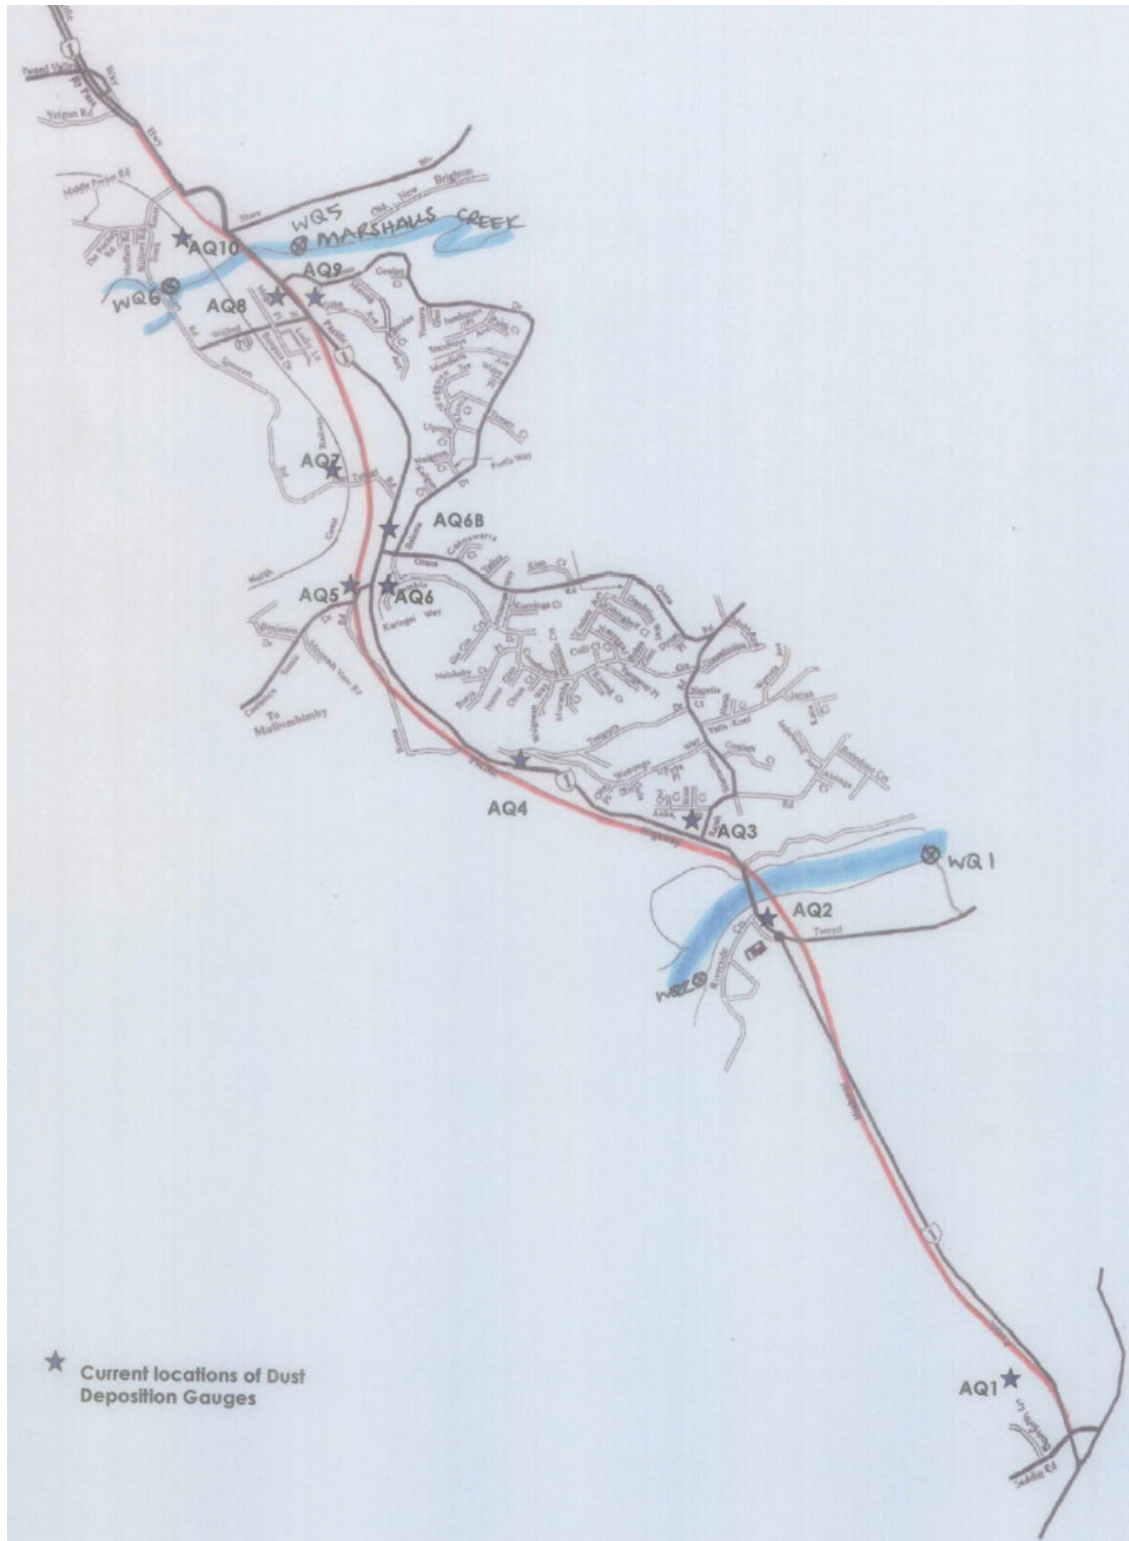
Figure 1: Brunswick Heads to Yelgun Pacific Highway Upgrade, showing monitoring locations for air quality (AQ) and water quality (WQ).

The Brunswick Heads to Yelgun Pacific Highway Upgrade is a 9 kilometre project awarded as a Design, Construct and Maintain (DCM) contract by the RTA to Abigroup Contractors in February 2005. The proposed new alignment is shown in Figure 1.
