**BRUNSWICK HEADS TO YELGUN
PACIFIC HIGHWAY UPGRADE PROJECT
FOURTH AND FINAL SIX MONTHLY REPORT ON
ENVIRONMENTAL PERFORMANCE**

JANUARY 2007 TO OCTOBER 2007

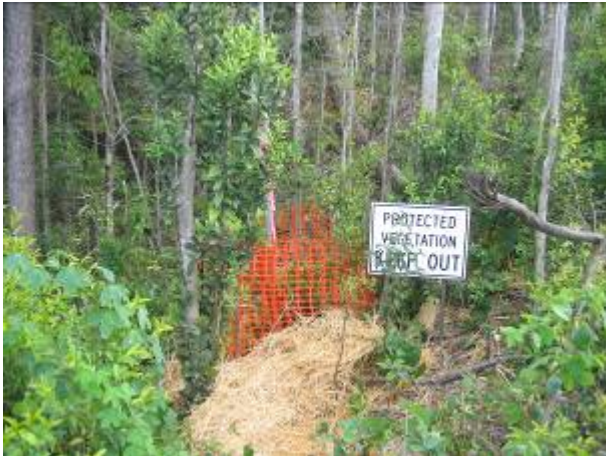
Photo 1: Typical signage and fencing protection to a threatened tree species adjacent to the highway upgrade alignment. Weed-free mulching was applied in 2007.

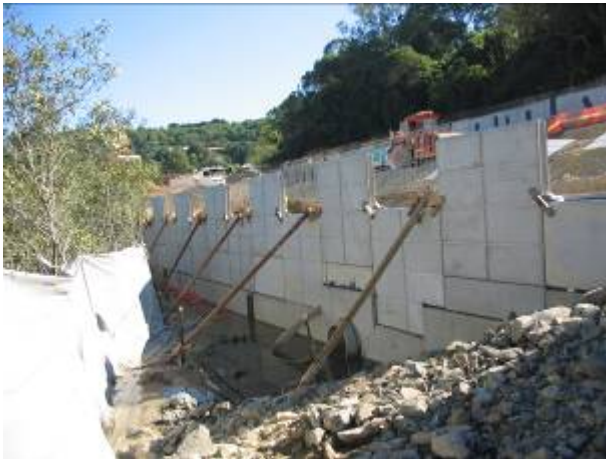
Photo 2: Impacts on the adjacent SEPP14 Coastal Wetland No 62 was minimised with the field delineation of vegetation clearing lines and a 3-metre high barrier fence. Staged removal of the 3-metre high fence was undertaken in consultation with DECC as Retaining Wall 1 was erected.

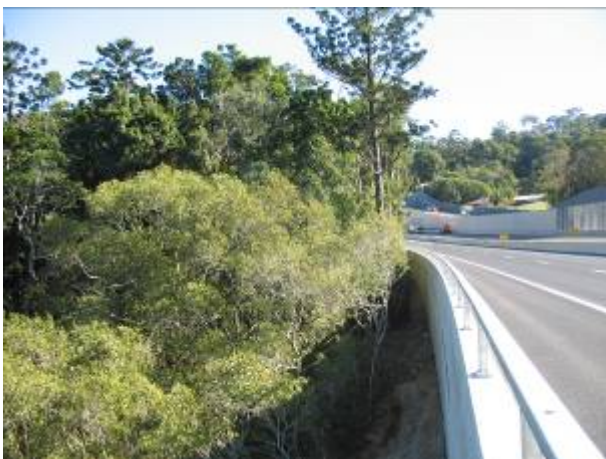
Photo 3: Completed highway upgrade adjacent to the SEPP14 wetland. The limited vegetation clearing has minimised impacts to the adjacent Brunswick Heads Nature Reserve.

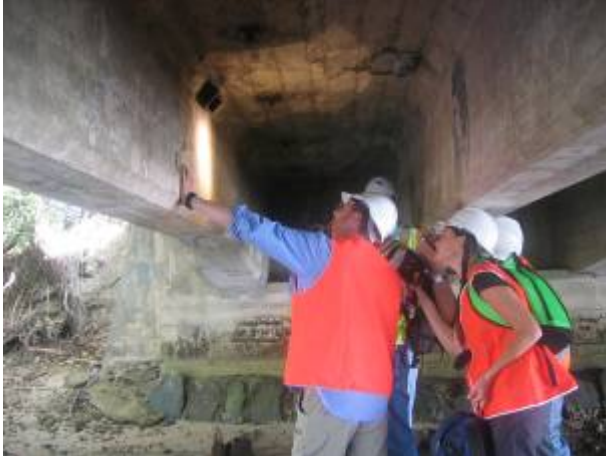
Photo 4: Following the discovery of a roost of bats (*myotis adversus*) under the old Brunswick River bridge, a bat translocation program was developed and implemented in April 2007 by the RTA in consultation with DECC and specialists from Eco Logical Australia.

An unexpected roost of approximately 109 micro-bats (*Myotis adversus*) was discovered in March 2007 as part of a pre-demolition inspection on the old Brunswick River bridge.

Specialist bat ecologists engaged by the RTA assisted the project team with the translocation of the bat colony prior to bridge demolition. An independent specialist bat ecologist was also engaged to undertake a peer review of the translocation methodology. There have been a number of learnings from this exercise, and the RTA is now applying these to other projects.

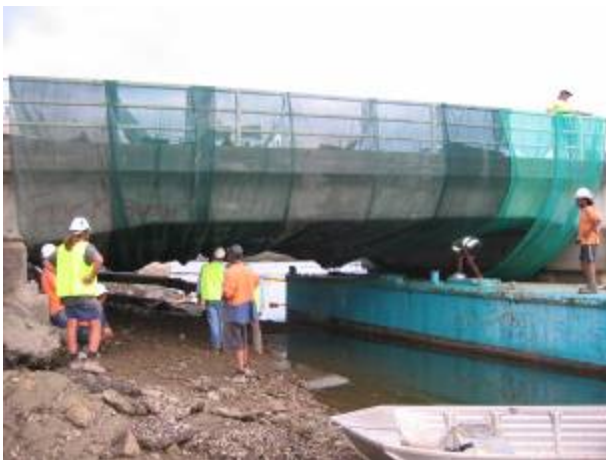
Photo 5: As part of the bat translocation plan, bat exclusion netting was placed over entire bridge spans that had been used by the bats, during staged demolition of the old bridge.

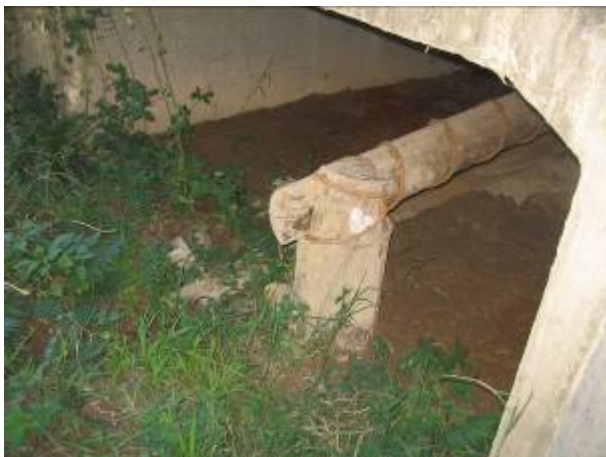
Photo 6: Furniture placed within the fauna underpass at C50.72.

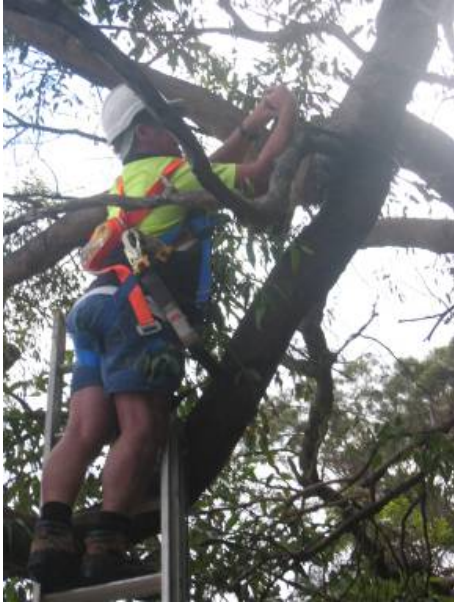
Photo 7: Fauna nesting boxes were installed around the Brunswick River area, including within the adjacent Brunswick River Nature Reserve in consultation with the DECC.

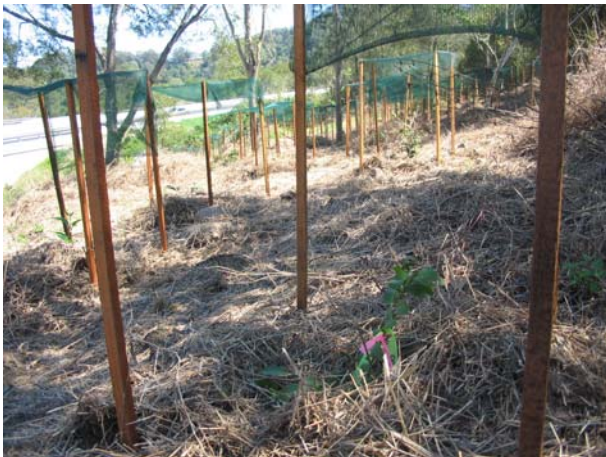
Photo 8: Planting of rare and threatened tree species adjacent to the highway alignment was undertaken in September 2007, in accordance with the Threatened Species Translocation Plan and addenda.

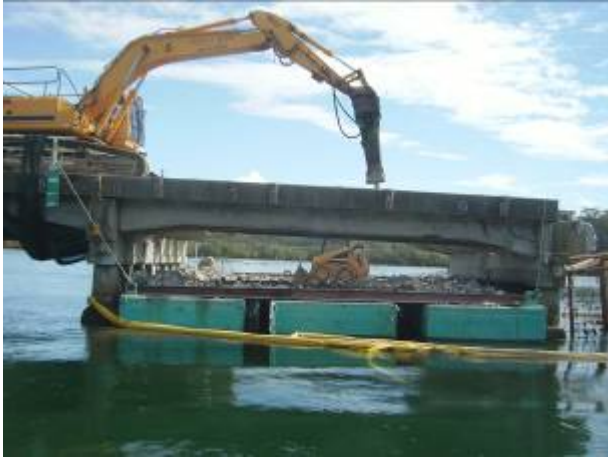
Photo 9: A catch barge located under the old bridge deck during demolition of the old Brunswick River bridge.

The demolition of the former Brunswick River bridge was undertaken using floating barges to capture and retain concrete fragments from the bridge deck structure. Due to unforeseen constraints, such as bat roosting and old timber piles, the work method statement was revised as the demolition process progressed, in an adaptive management approach. State agency representatives and the EMR were kept informed of the developments with the work method statement.

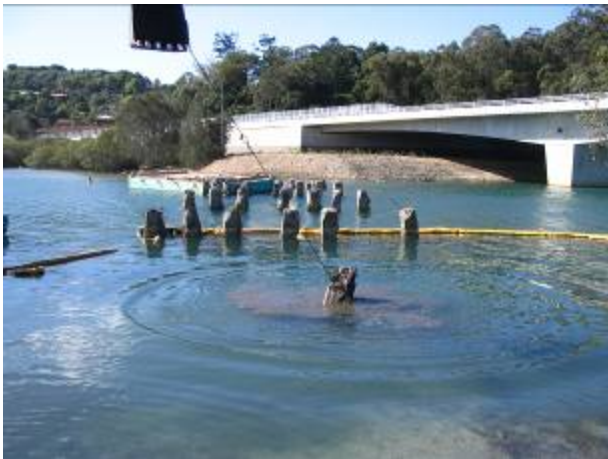
Photo 10: Old bridge pile being removed.

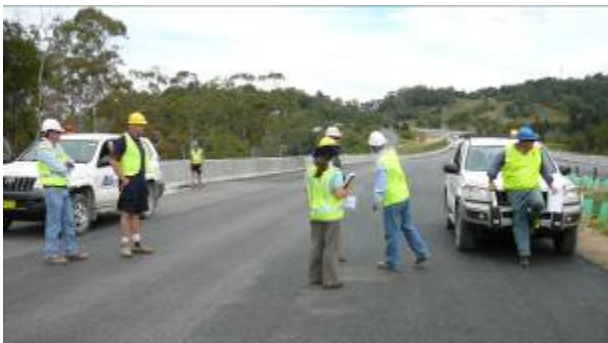
Photo 11: Environmental inspection on 2 May 2007 with representatives of the RTA, DECC and other state government agencies present. An assessment of the site stabilisation was undertaken to support an application to remove some sediment basins from the Environmental

Protection Licence with DECC. Progressive revegetation in basin catchment areas was considered generally successful.

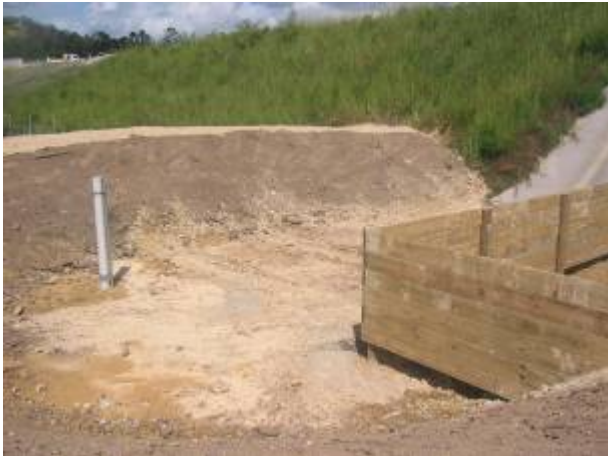
Photo 12: Detail of a typical water quality basin, used during construction as a sediment basin and in post-construction as a permanent spill basin. Photo shows an oil baffle system and low flow outlet.

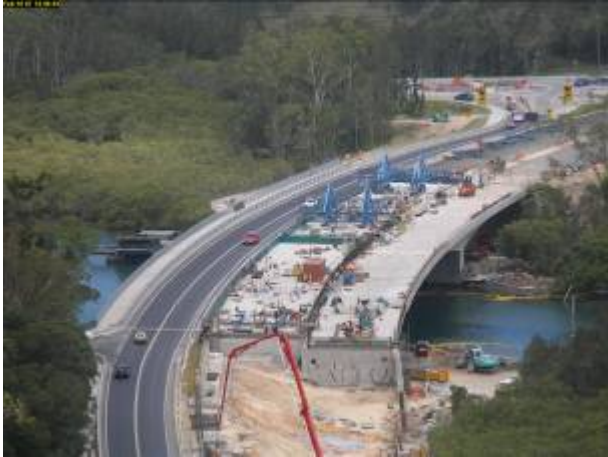
Photo 13: Brunswick River Bridge work site during February 2007.

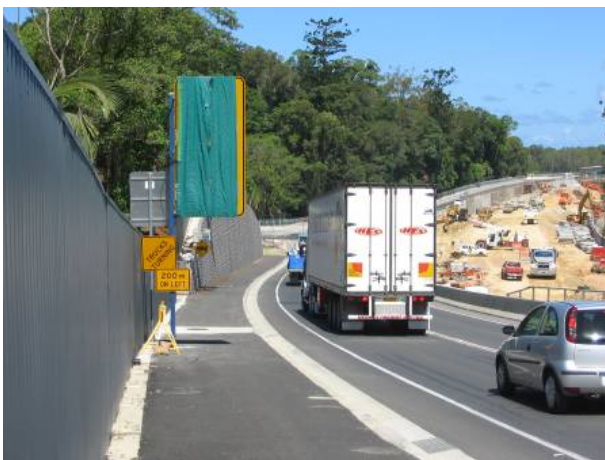
Photo 14: The permanent noise barrier wall (left hand side) near Rajah Noise is visible in this photo, and provided some noise protection while the highway traffic temporarily travelled on the new Service Road (Brunswick Valley Way).

- The erection of the noise barrier along the boundary in the Rajah Road area. Because of the complexity of the construction of an adjacent retaining wall, the timing of this noise barrier was staged in consultation the DECC (EPA) due to engineering, design development and practical implementation issues which were encountered during the process;

- Using temporary noise shields. An example of this occurred when, for practical reasons, the permanent noise wall at Rajah Road was delayed, and so a temporary noise shield was erected along the boundary;

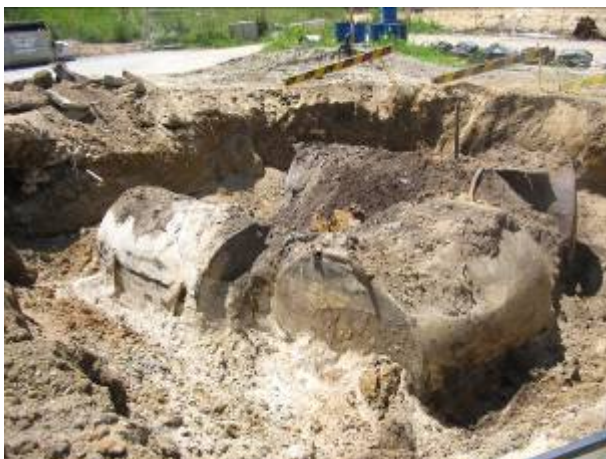
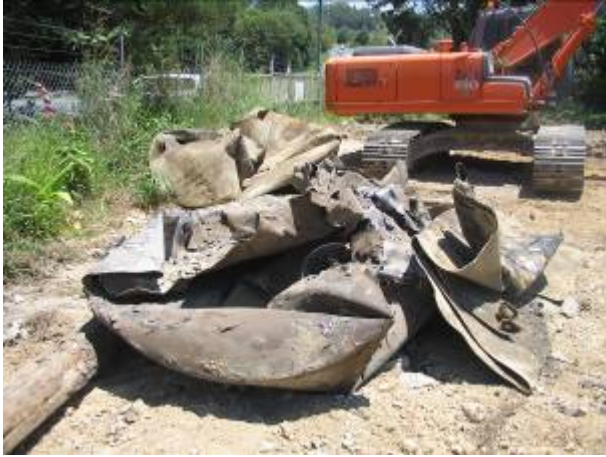
Photo 15 and 16: Disused underground storage tanks exposed, and removed from site.

The remediation of the cattle tick dip site was undertaken in the previous reporting period and the Ocean Shores service station site was remediated during this reporting period. Five disused underground storage tanks were exposed, and removed from the site. The surrounding soil was excavated and rehabilitated by a “landfarming” method. A Validation Report and a final Site Assessment Report documenting this activity is being prepared by an external consultant and will be forwarded to DECC.
