## **3.12 Visual And Landscape Assessment**

### **3.12.2 Landscape Plan**

### **3.12.4 Final Planting**

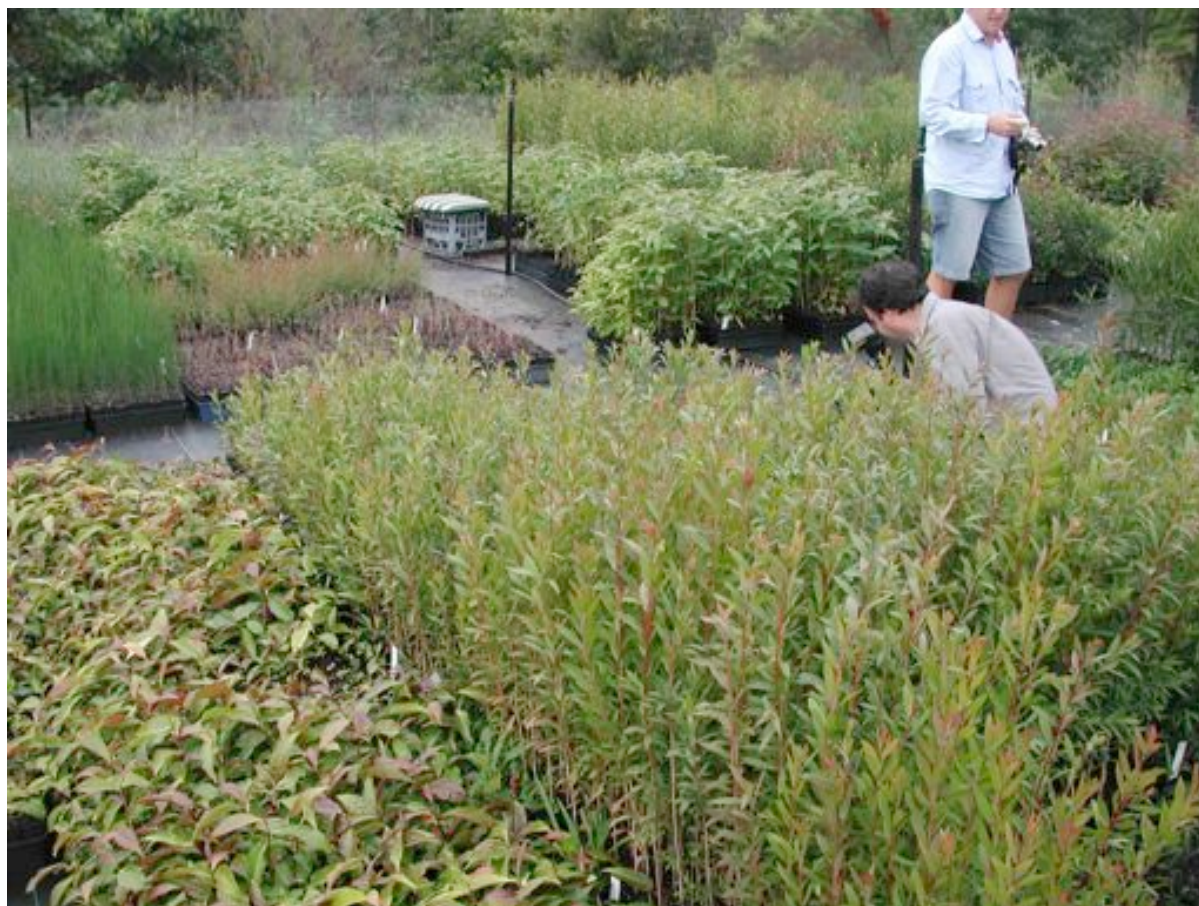
**Photograph 3.36** Inspecting plants grown from local seed-stock and destined for use in the final landscaping of the Upgrade.

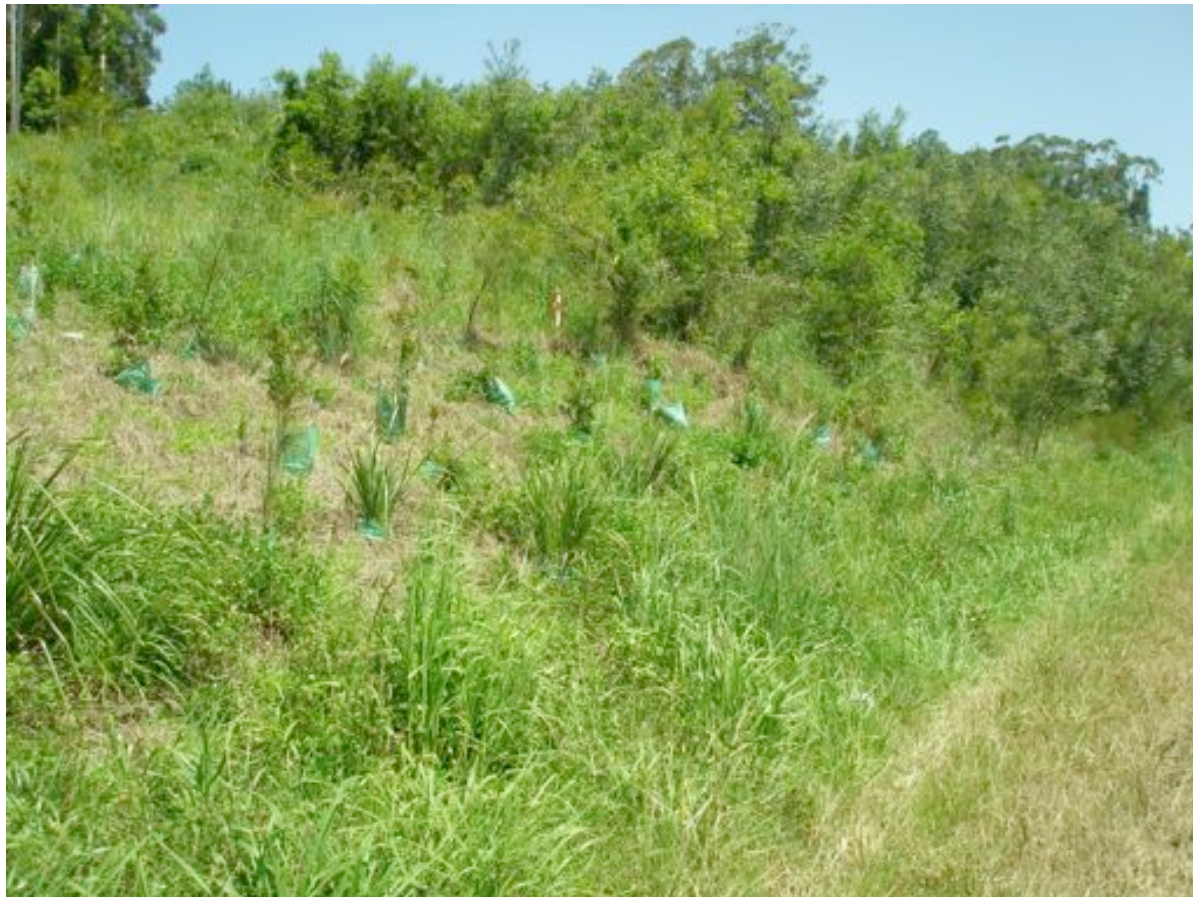
**Photograph 3.37** Two different revegetation strategies are evident here. The trees in the foreground were planted into a grassed bank, whilst those in the background have grown from seed. It is hoped that the pioneer species in the background will eventually be replaced by other species in the seed mix. The planting in the foreground will need to be actively managed for some years until the trees grow large enough to out-compete the grasses.

In some areas the pasture grasses used in the northern section of the project have been out-competing the tube-stock and mowing and slashing has been, and will continue to be, required to reduce this competition until the plants are large enough to shade-out these grasses. There is a significant cost implication associated with the decision to use these grasses. They may have lowered construction costs, but have significantly increased maintenance costs. It is considered likely that the overall cost is higher than if a more suitable erosion control product had been utilised with a higher mulch component on the steeper slopes.

The practice of planting tube stock into areas where grasses are already established and growing well requires more effort (greater cost) to minimise competition from the grasses. This includes soil preparation (herbicides, ameliorants and fertilisers), the use of weed-mat, and follow-up spraying and mowing until the plants are well established. This wasn't performed during planting and the plants have suffered as a consequence.

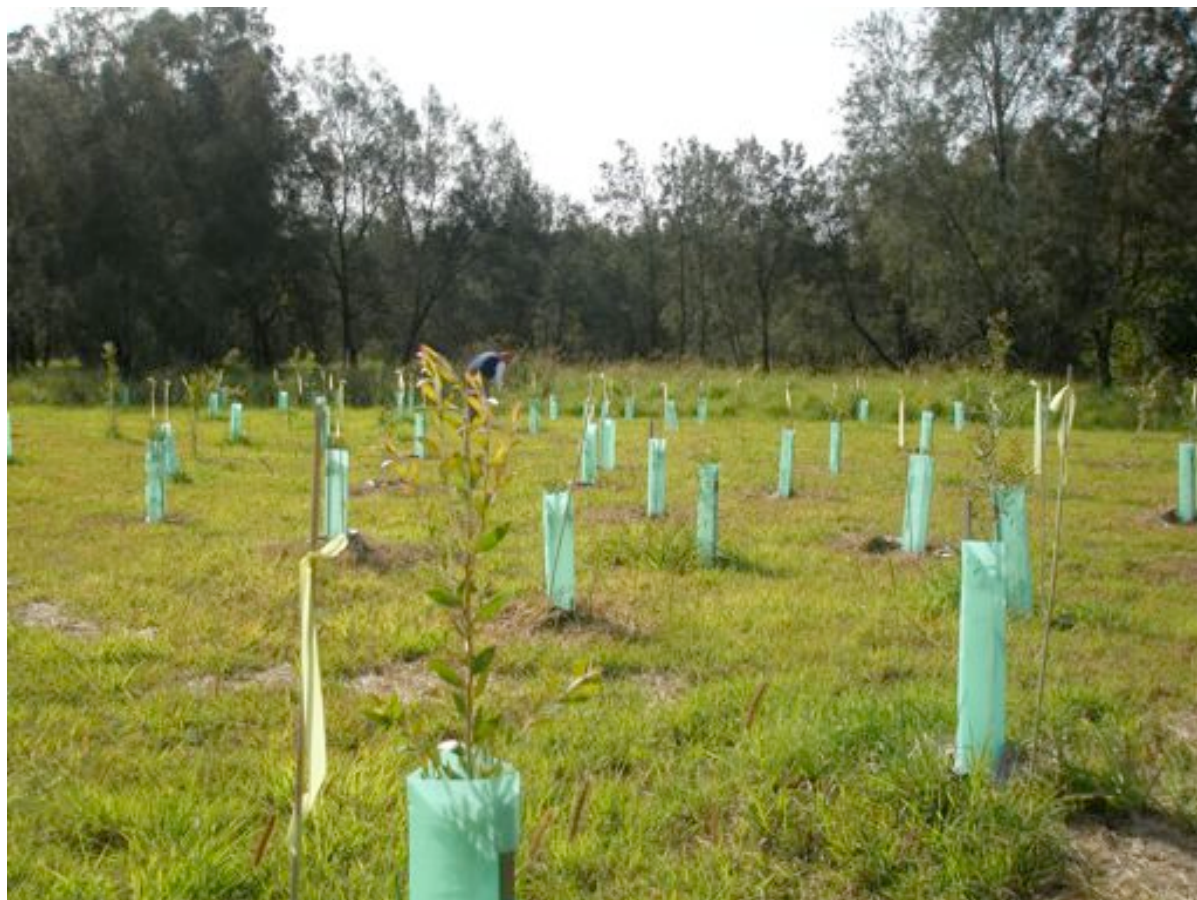
**Photograph 3.38** An example of how much effort is required to grow plants in areas dominated by established pasture grasses. This exceptional growth was achieved by active weed suppression using chemicals and physical means (mowing and slashing), soil amelioration, and slow-release fertiliser. These plants are four-month old tubestock. The higher establishment cost was off-set by the low mortality of 2%.
