**REPORTING SUMMARY OF MONITORING RESULTS**

BRUNSWICK HEADS TO YELGUN

PACIFIC HIGHWAY UPGRADE PROJECT

This is the monthly monitoring report for the calendar month of February 2007.

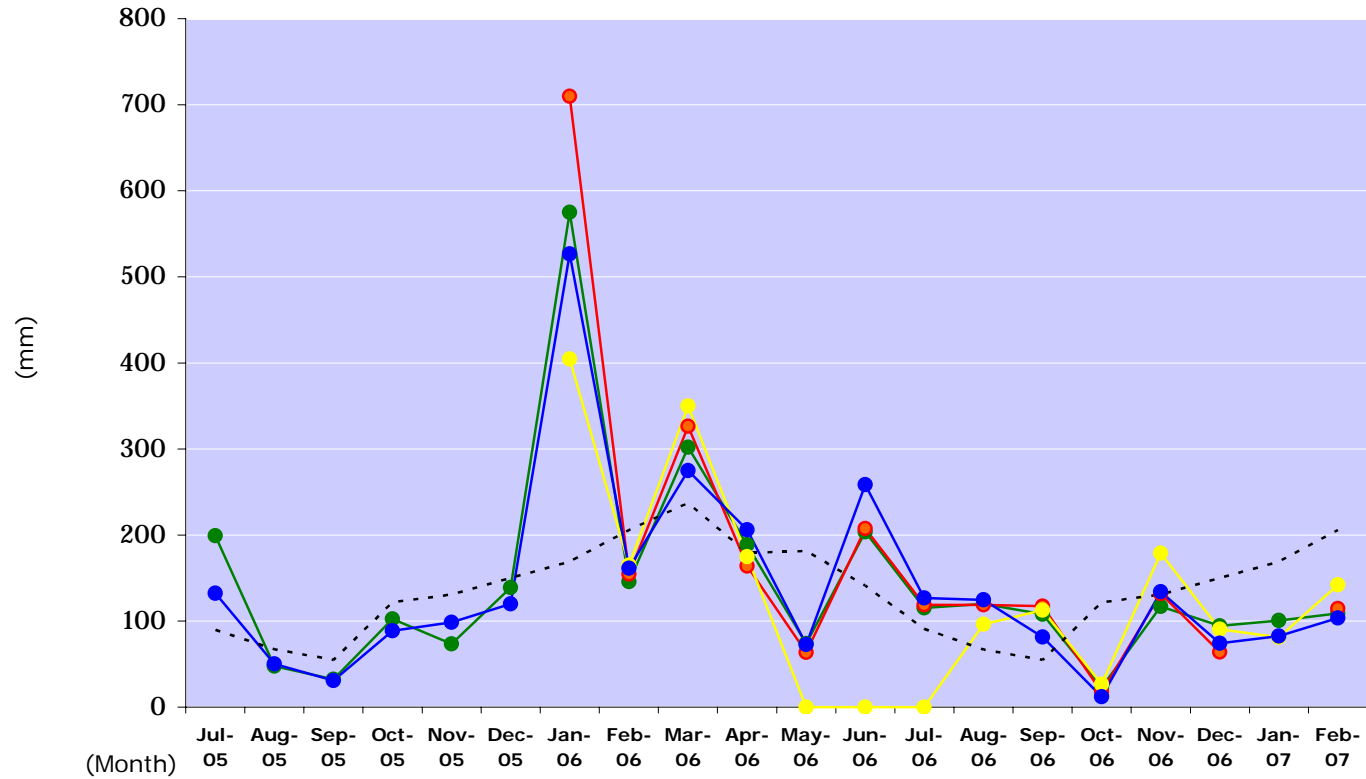
Graph 1:- Comparative rainfall data for the Brunswick Heads to Yelgun Pacific Highway Upgrade

Most of the rain was received during the second week of February, with the heaviest rainfall for the month recorded on the 13 February (70mm).

During February there was substantially less rain received in comparison to the monthly average – 205.6mm.

Jul-05	Aug-05	Sep-05	Oct-05	Nov-05	Dec-05	Jan-06	Feb-06	Mar-06	Apr-06	May-06	Jun-06	Jul-06	Aug-06	Sep-06	Oct-06	Nov-06	Dec-06	Jan-07	Feb-07
Site Office	199.3	47.7	32.5	102.5	73.6	139	575	145.8	302.2	188.7	73.9	203.6	115.4	120	107.8	22.8	117	94.5	100.5	109
Workshop							710	154.5	326.5	164	63.5	207.5	119	119	117.5	17.5	132	64		114.5
Northern Compound							404.5	165	350	175	0	0	0	96.5	112.5	26.5	179	90.5	81	142
Brunswick Heads Bowls Club	132.2	50	30.8	88.8	98.4	119.8	526.8	161.2	274.8	206.2	72.6	258.4	127	124.6	81.4	12	134	74.2	82.4	103.5
Monthly Average (Historical Data 1964-2004)	89.89	67.29	54.86	121.64	130.75	149.96	168.99	205.69	237.09	179.07	181.28	141.15	90.89	66.88	54.86	121.64	130.75	149.96	168.99	205.69

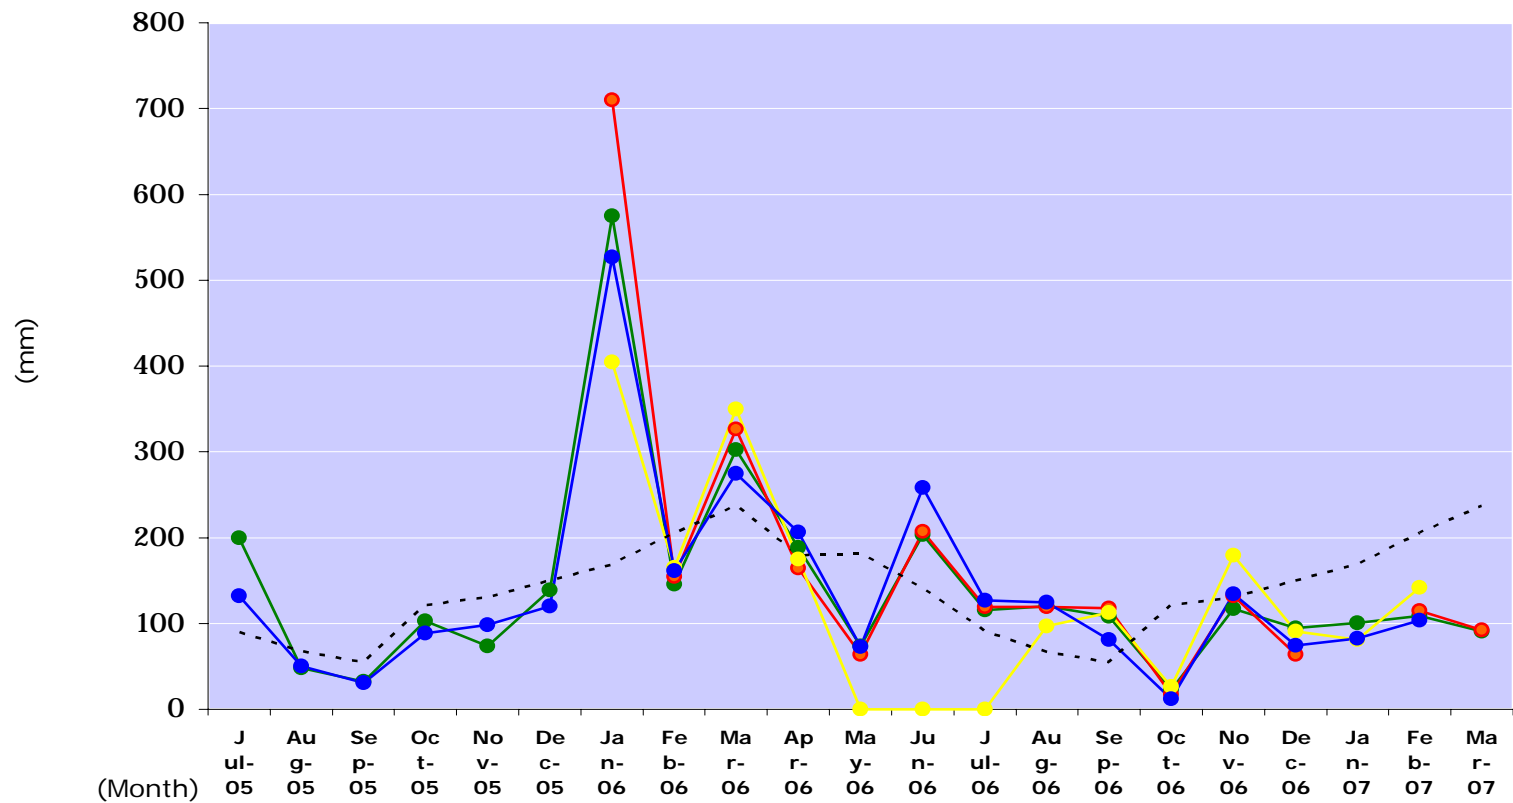
Graph 1:- Comparative rainfall data for the Brunswick Heads to Yelgun Pacific Highway Upgrade

During March there was substantially less rain received in comparison to the monthly average which is 237.09mm.

Jul-05	Aug-05	Sep-05	Oct-05	Nov-05	Dec-05	Jan-06	Feb-06	Mar-06	Apr-06	May-06	Jun-06	Jul-06	Aug-06	Sep-06	Oct-06	Nov-06	Dec-06	Jan-07	Feb-07	Mar-07
Site Office	199.3	47.7	32.5	102.5	73.6	139	575	145.8	302.2	188.7	73.9	203.6	115.4	120	107.8	22.8	117	94.5	100.5	109	90.5
Workshop							710	154.5	326.5	164	63.5	207.5	119	119	117.5	17.5	132	64		114.5	92.5
Northern Compound							404.5	165	350	175	0	0	0	96.5	112.5	26.5	179	90.5	81	142	
Brunswick Heads Bowls Club	132.2	50	30.8	88.8	98.4	119.8	526.8	161.2	274.8	206.2	72.6	258.4	127	124.6	81.4	12	134	74.2	82.4	103.5	
Monthly Average (Historical Data 1964-2004)	89.89	67.29	54.86	121.64	130.75	149.96	168.99	205.69	237.09	179.07	181.28	141.15	90.89	66.88	54.86	121.64	130.75	149.96	168.99	205.69	237.09

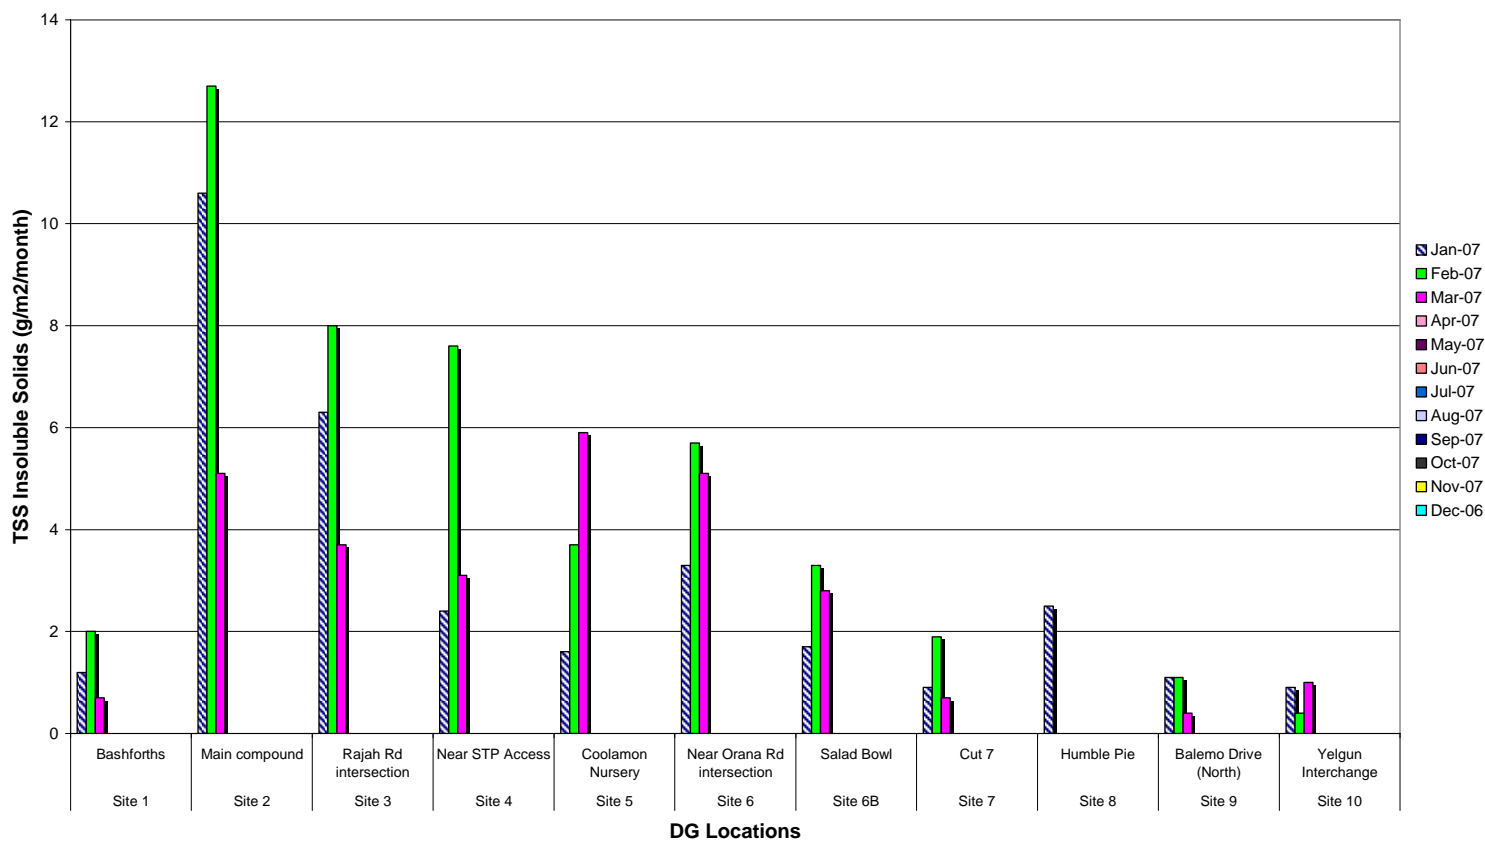
**Dust Monitoring Results  
B2Y 2007**

<b>Site</b>	<b>Total Suspended Solids (g/m<sup>2</sup>/month)</b>
1. Cut 2 near Bashforth property	0.7
2. Main Compound	5.1
3. Rajah Road intersection	3.7
4. Near STP Access	3.1
5. Coolamon Nursery	5.9
6A. Near Orana Rd intersection	5.1
6B. Outside workshop	2.8
7. Cut 7 The Tunnel Road	0.7
8. Outside Humble Pie business	n/a
9. Balemo Drive (north)	0.4
10. Yelgun Interchange	1.0

Site 8 has not achieved a result for March. At the end of February, the laboratory went to this site and noted that the gauge was missing possibly from site works or vandalism. It was not until 20 March (when the laboratory sent through the dust results through for February) that Abigroup were advised that this gauge was in fact missing. The gauge was immediately installed the next day (21 March) but will not effectively start recording until 1 April as the dust gauge bottle and glass funnel were installed by the laboratory on that day, and monitoring must be representative of an entire month.

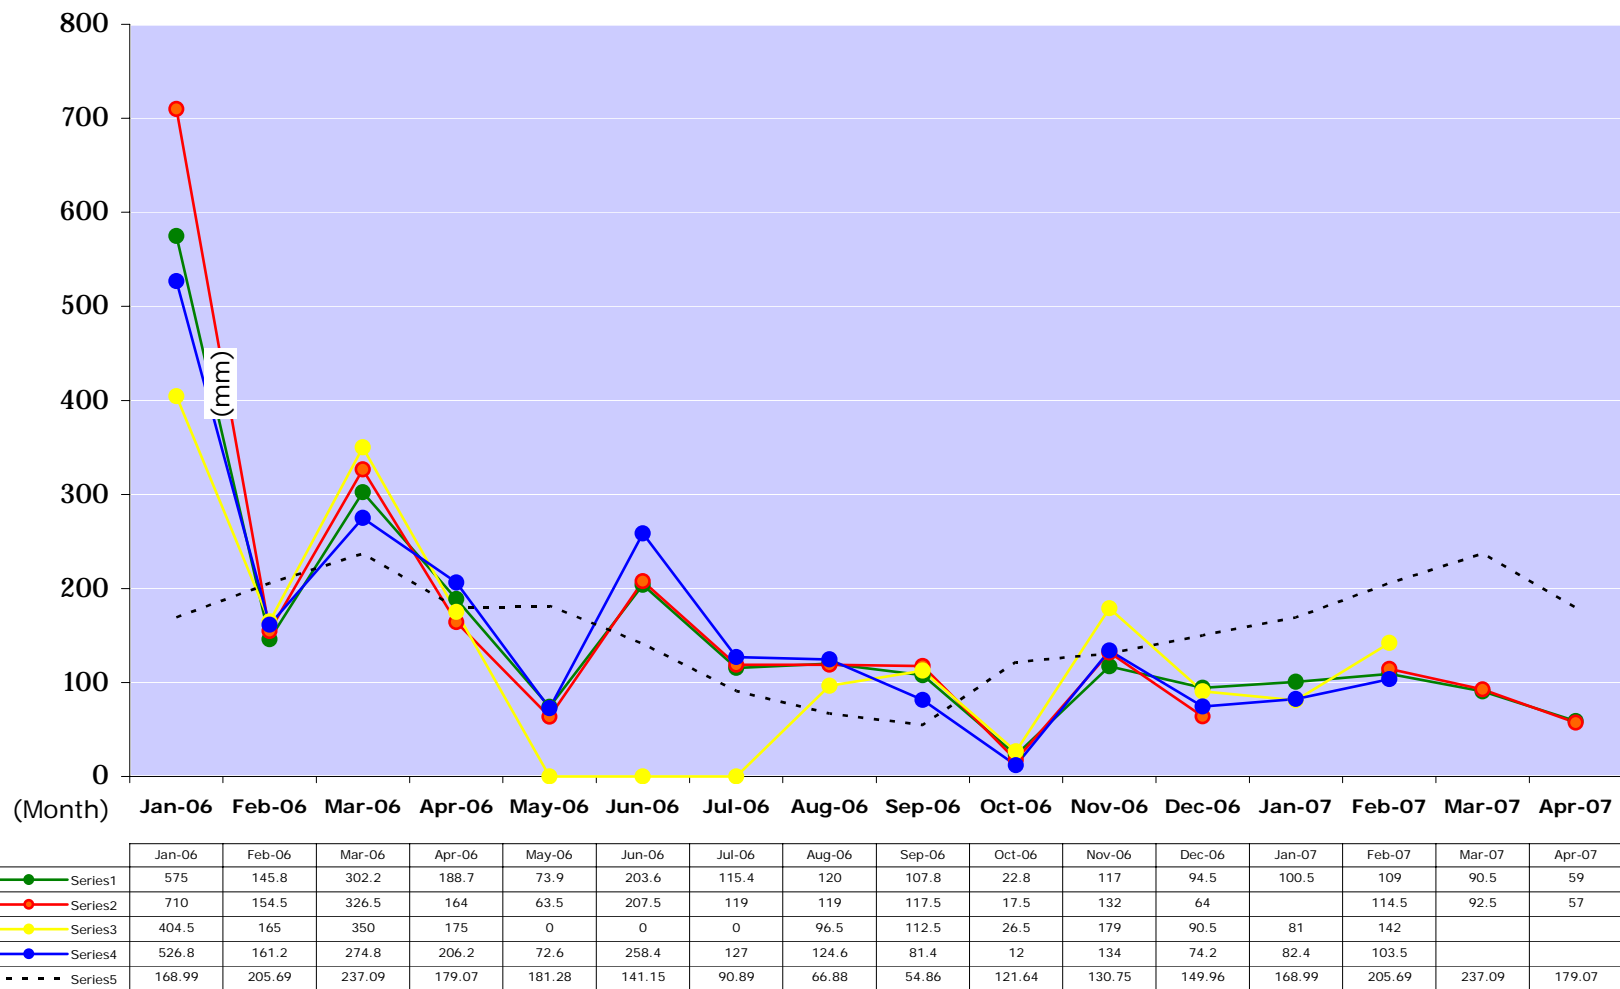
Graph 1:- Comparative rainfall data for the Brunswick Heads to Yelgun Pacific Highway Upgrade

During April there was substantially less rain received in comparison to the monthly average which is 179.07mm.

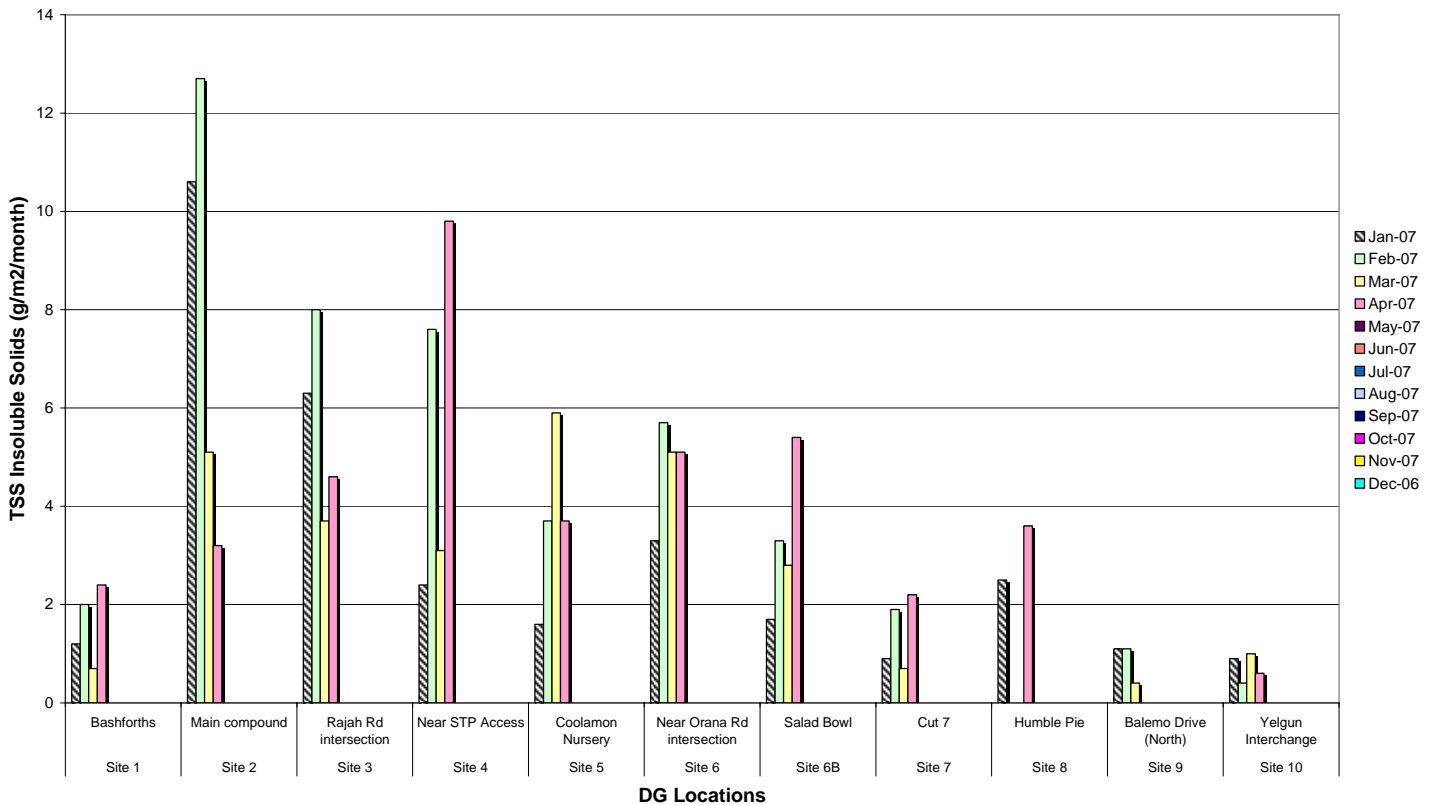
**Dust Monitoring Results  
B2Y 2007**

<b>Site</b>	<b>Total Suspended Solids (g/m<sup>2</sup>/month)</b>
1. Cut 2 near Bashforth property	2.4
2. Main Compound	3.2
3. Rajah Road intersection	4.6
4. Near STP Access	9.8
5. Coolamon Nursery	3.7
6A. Near Orana Rd intersection	5.1
6B. Outside workshop	5.4
7. Cut 7 The Tunnel Road	2.2
8. Outside Humble Pie business	3.6
9. Balemo Drive (north)	n/a
10. Yelgun Interchange	0.6

Dust results for April indicate four exceedances – Site 3 (Rajah Road), Site 4 (STP Access Road), Site 6A (Orana Road intersection) and Site 6B (Salad Bowl). A discussion of the activities occurring at these sites and any factors that may have contributed to the results is provided below.

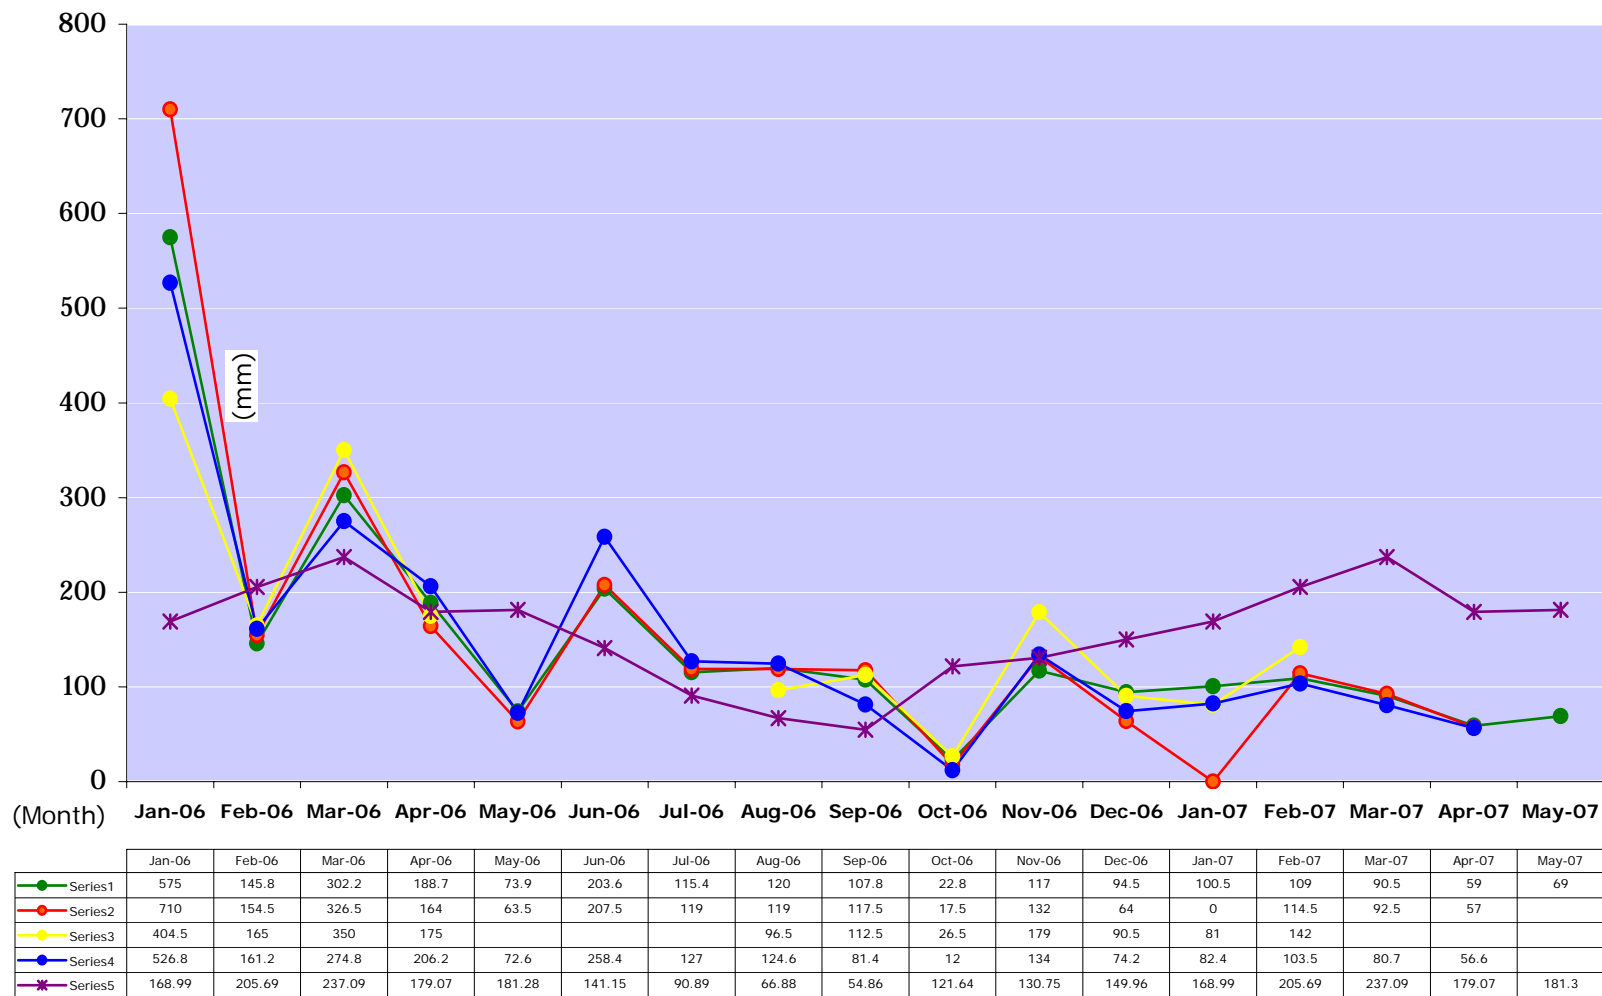
Graph 1:- Comparative rainfall data for the Brunswick Heads to Yelgun Pacific Highway Upgrade

During May there was substantially less rain received in comparison to the monthly average which is 181.28mm.

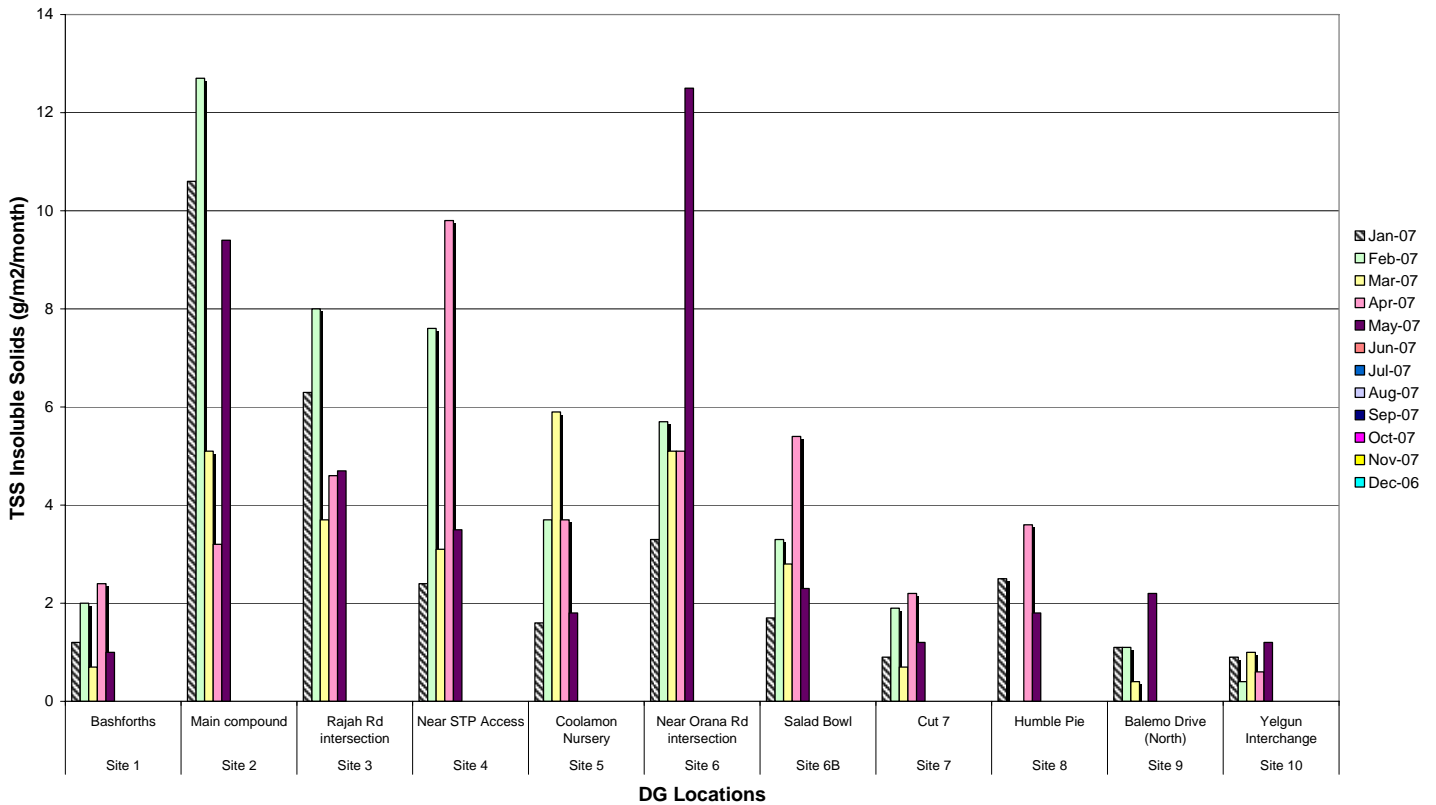
**Dust Monitoring Results  
B2Y 2007**

<b>Site</b>	<b>Total Suspended Solids (g/m<sup>2</sup>/month)</b>
1. Cut 2 near Bashforth property	1.0
2. Main Compound	9.4
3. Rajah Road intersection	4.7
4. Near STP Access	3.5
5. Coolamon Nursery	1.8
6A. Near Orana Rd intersection	12.5
6B. Outside workshop	2.3
7. Cut 7 The Tunnel Road	1.2
8. Outside Humble Pie business	1.8
9. Balemo Drive (north)	2.2
10. Yelgun Interchange	1.2

Dust results for May indicate three exceedances – Site 2 (Site office), Site 3 (Rajah Road), and Site 6A (Orana Road intersection). A discussion of the activities occurring at these sites and any factors that may have contributed to the results is provided below.
